MEMO

Re: Summary of Initial Findings from Site Visit at Glenwood Middle School located in Glenwood, MD

Glenwood Middle School – Glenwood, MD

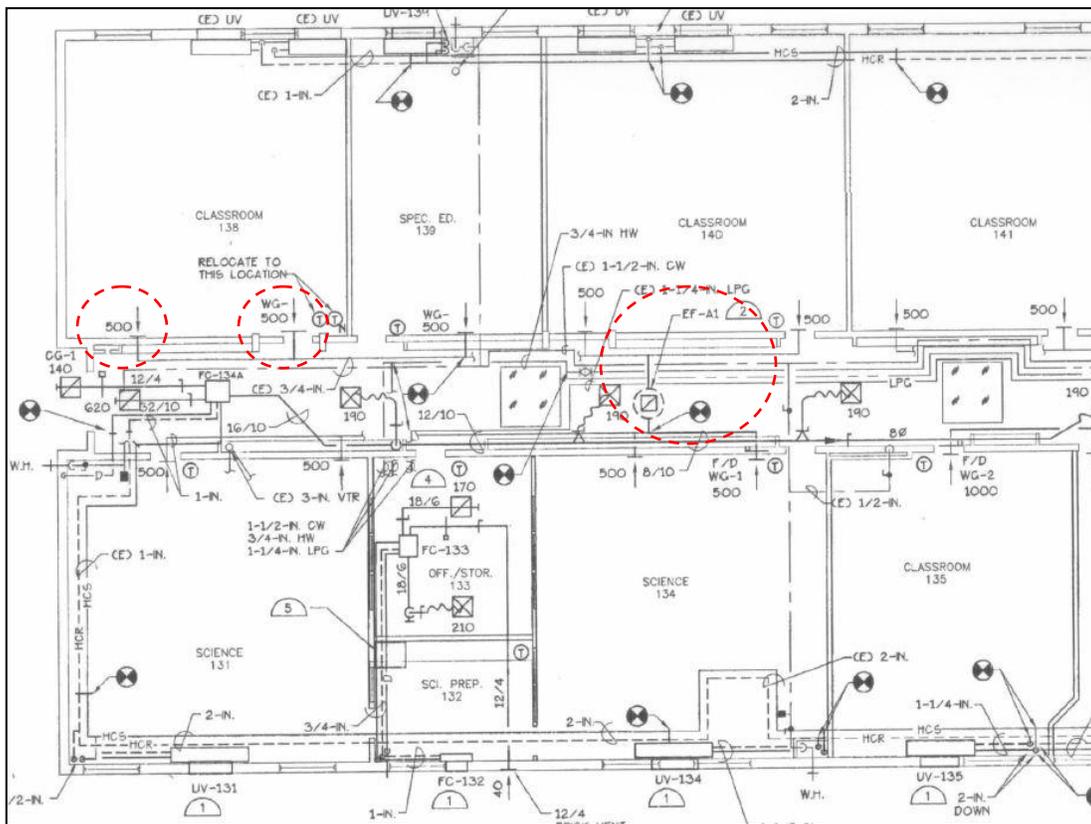
- Exhaust Fans Operating without Make-up Air: The building contains multiple exhaust fans serving the classrooms, restrooms and the school kitchen. Each classroom wing contains two exhaust fans that exhaust air from the classrooms through one or two exhaust grilles located in each room. All exhaust fans are operational during the occupied time period. A lack of make-up air from the HVAC systems is causing the building to operate under a large negative pressure. This permits unconditioned air to infiltrate in to the building through doors, windows, the old steam tunnel (crawl space) and the boiler exhaust flue. Based on a review of the older design drawings for the building and the subsequent renovation drawings, the exhaust fans in the classrooms wings should only operate any time the unit ventilators are in the economizer mode. However, based on a review of the fans at the building, it appears that the fans are operating continuously during the occupied time period, regardless of unit ventilator outside air damper position.

Red circled area shows one of the two exhaust fans serving Classroom Wing A and exhaust from classroom

- *Turn off classroom and hallway exhaust fans:* In order to prevent excessive exhaust air from pulling a negative pressure in the facility, it is recommended that the facility staff cycle off the exhaust fans. The exhaust fans are designed to remove approximately 15,000 CFM when the unit ventilators are in “economizer” mode (OA dampers fully open); however the majority of the unit ventilator OA dampers open to only 5-8% (as currently operating). It is unclear at this time if this is a result of improper set up, faulty equipment, not enough pneumatic pressure or actuators that have failed. However, reducing the exhaust will reduce the unconditioned air infiltration and reduce humidity within the facility.

- *Operate main exhaust fans on VFD (variable frequency drives):* The exhaust fans are currently drawing more CFM than is re-introduced (properly conditioned) to the building causing a humid and uncomfortable temperature. It may be feasible to operate the exhaust fans on VFD's, managing the amount of air exhausted via static pressure. This type of operation will reduce the negative pressure within the building as well as reduce the speed of the exhaust fan motors, when not required to operate at 100%. New exhaust fan motors and controls/ATC may be required in order to properly operate them on VFD's, however, savings will be found in the way of reduced motor operation.

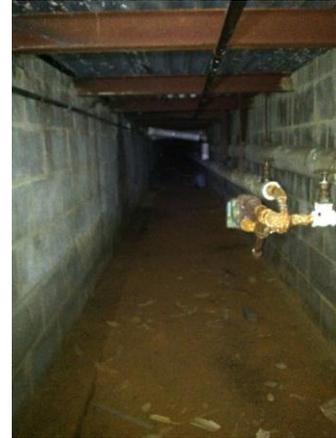
- Odor from Old Steam Tunnel: Old steam tunnels exist under the classroom wings along the entire perimeter wall of each classroom wing. The tunnels were used to pipe steam directly to the old Classroom Unit Ventilators that once contained steam heating coils. Old pipe penetrations are still visible today within the unit ventilator cabinet. The tunnel has a dirt floor and areas checked appear to be damp with a musty smell from the dirt. Since the building is under negative pressure, air from the tunnels is drawn in to the building through cracks or holes in the floor at the unit ventilators and remaining access hatches located in

the floor. The musty odor from the tunnels is more prevalent in some rooms due to a higher concentration of openings through the floor. Some floor penetrations within the unit ventilator cabinets have been sealed with expanding foam, but a review of several unit ventilators indicates air infiltration from the tunnel remains.

Old Steam Tunnel – Dirt Floor

- *Seal existing steam pipe penetrations in unit ventilators:* It was noticed that there is humid, unconditioned, musty smelling air entering many unit ventilators from the crawl space below. The existing/abandoned steam piping penetrations come through the crawl space floor, and introduce unconditioned, humid air into the unit ventilator cabinet. This air is bypassing the cooling coil and dumping directly into the classrooms. Sealing these floor penetrations with spray foam may help in reducing this infiltration and odors.

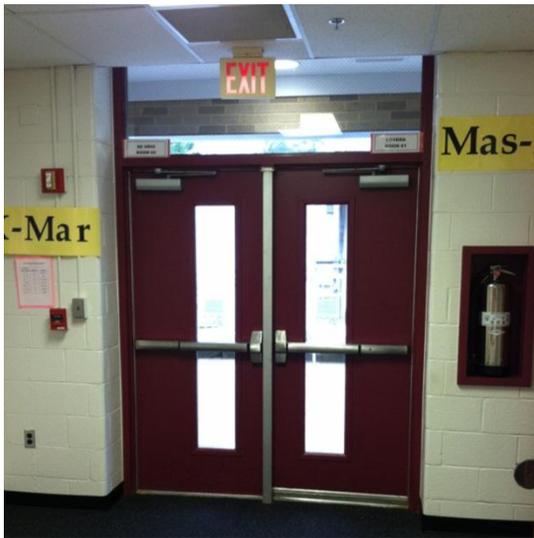
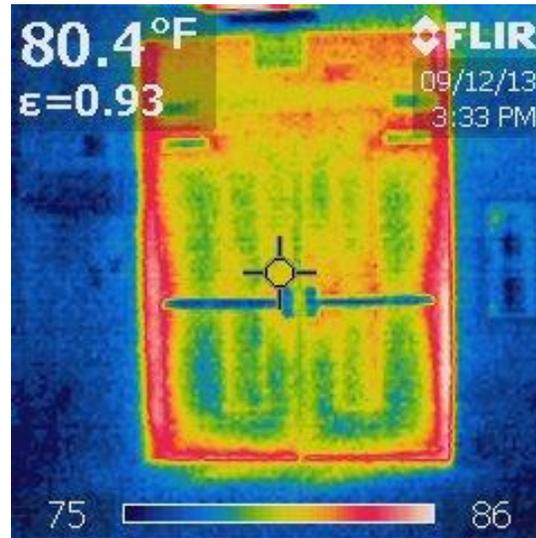
Exterior door in middle classroom wing hallway. IR Photo shows higher temperature around the door edges indicating air infiltration through the door edges.

- *Weatherization for doors and exterior openings:* Similar to the above mentioned recommendation, it may be necessary to seal major openings for exterior doors and windows. It is critical to get as good as seal as possible when doors and windows are shut to reduce unconditioned air from entering the occupied spaces. Sealing and/or caulking these penetrations may help in reducing this infiltration.

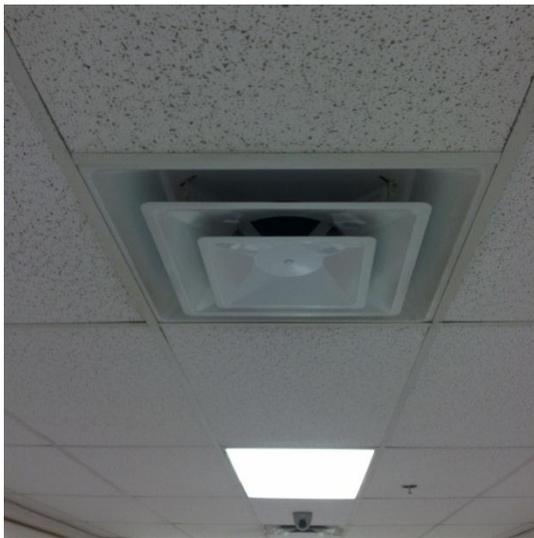
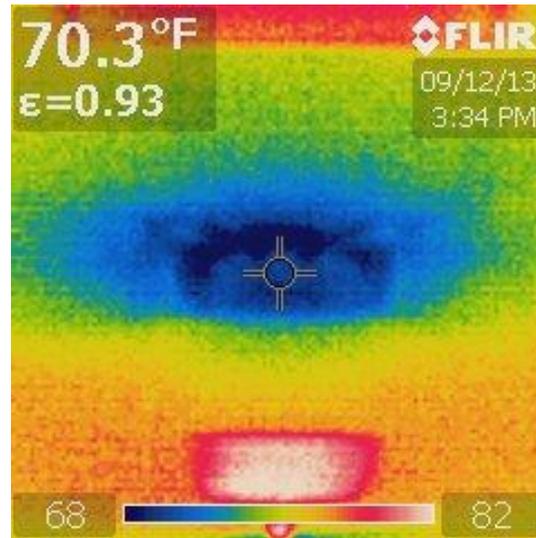
Supply air diffuser from Hallway Fan-Coil unit. IR Photo shows that the hallway unit is currently supplying 68 deg F air. No evidence of condensation at the time of the audit.

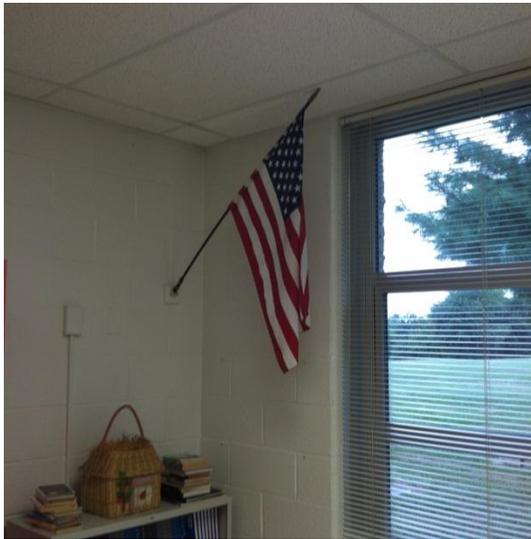
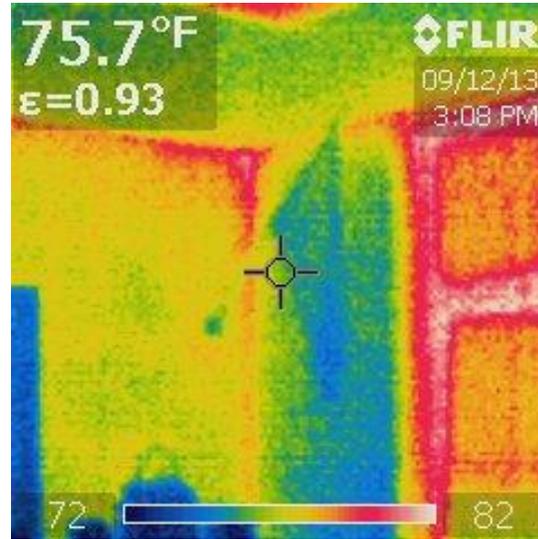
IR Photo of exterior wall and window in Room 31. IR Image indicates heat infiltration at window frame and corner of wall.

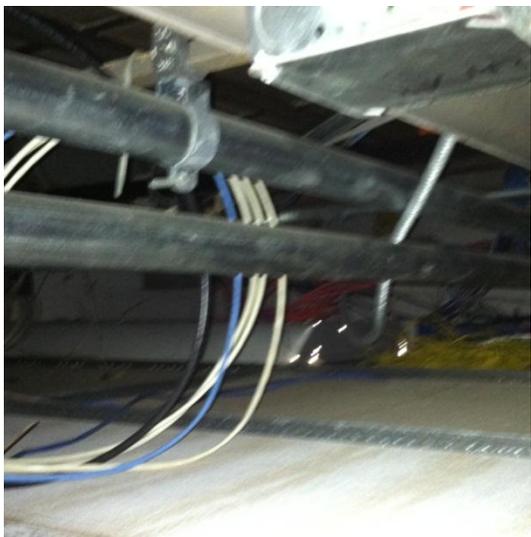
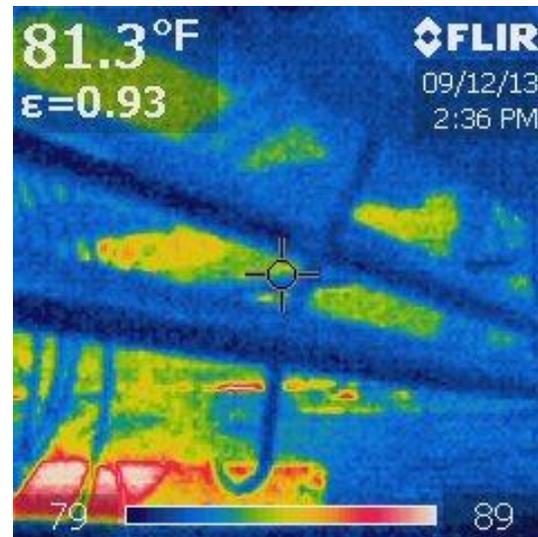
IR Photo above Room 33 ceiling tiles. Minimal heat loss through roof indicated.

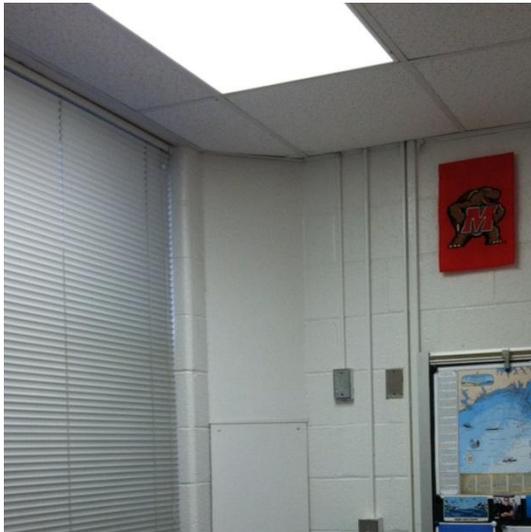
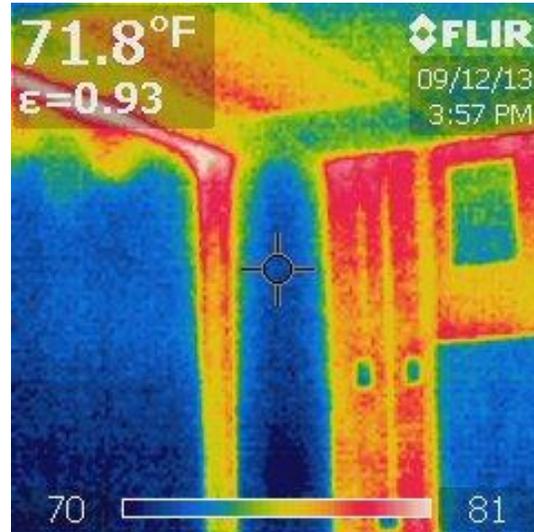
IR Photo of south wall in Room 11. Shows heat infiltration along south wall and around window frame. Negative air pressure within the building appears to be drawing air through cracks in the exterior wall and around the window frames.

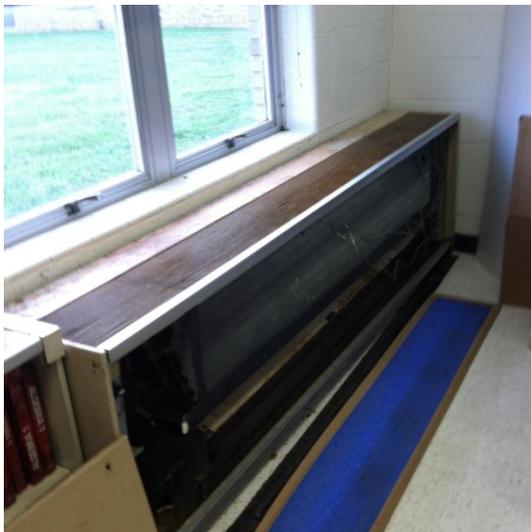
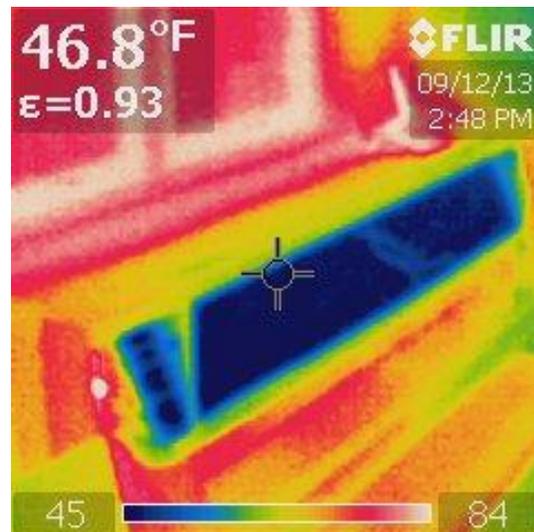
IR Photo of Room 33 Unit Ventilator interior showing cooling coil, unit interior and classroom window in background. The IR photo indicates heat infiltration inside the unit ventilator and around the window frame.

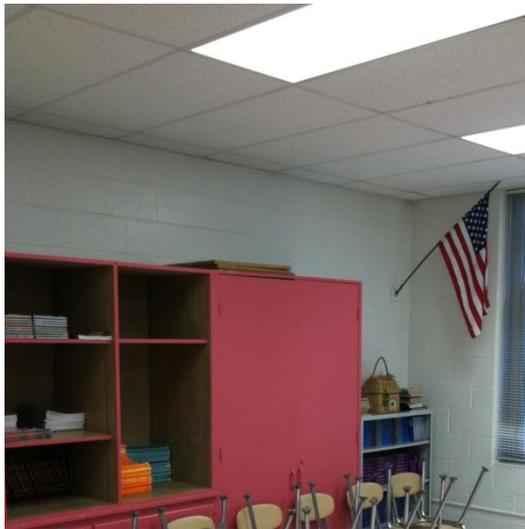
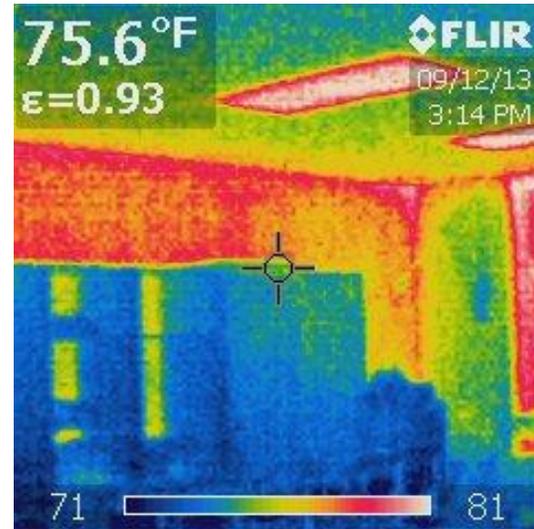
IR Photo of Room 31 showing heat infiltration along the back wall behind cabinets and at window near the Unit Ventilator. Wall behind the cabinets is a West facing wall and the IR image was captured at approximately 4:00PM.

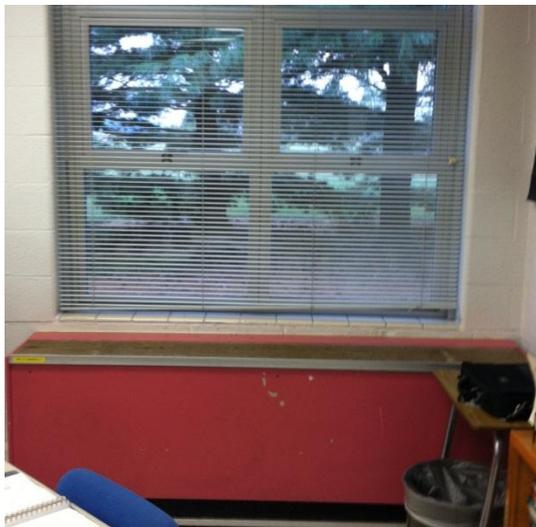
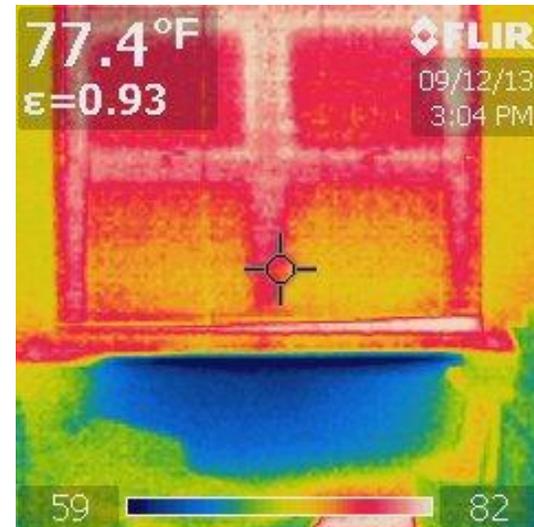
IR Photo of Room 31 Unit Ventilator and window. IR Photo shows heat infiltration at the window frame and window sill above the unit ventilator. Condensation was noted on the Unit Ventilator right side outer panel.

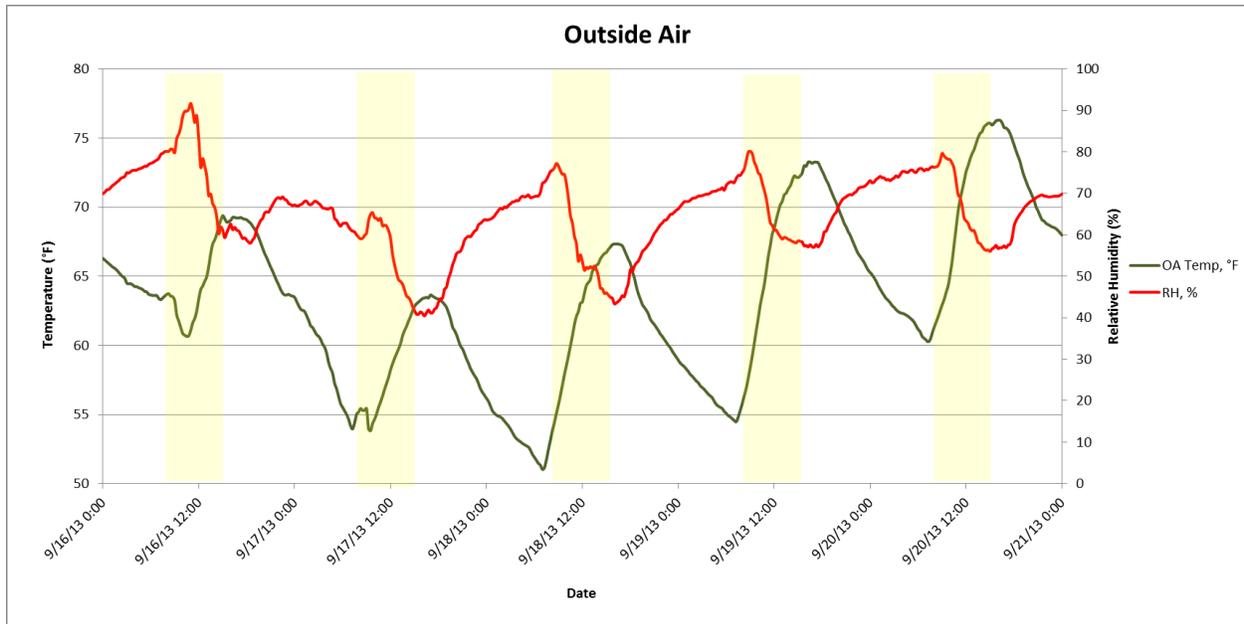
The above graph provides a summary of the outside air temperature and relative humidity as measured by the data logger placed outside near the cafeteria on the north side of the building. The data loggers were installed for over a 7 day period spanning a full week of school days and two weekends. As can be seen in the graph above, the outside air temperature and humidity unfortunately do not represent the peak temperature and humidity that is experienced during the summer months. NOTE: Yellow bars indicate “occupied” hours each day.

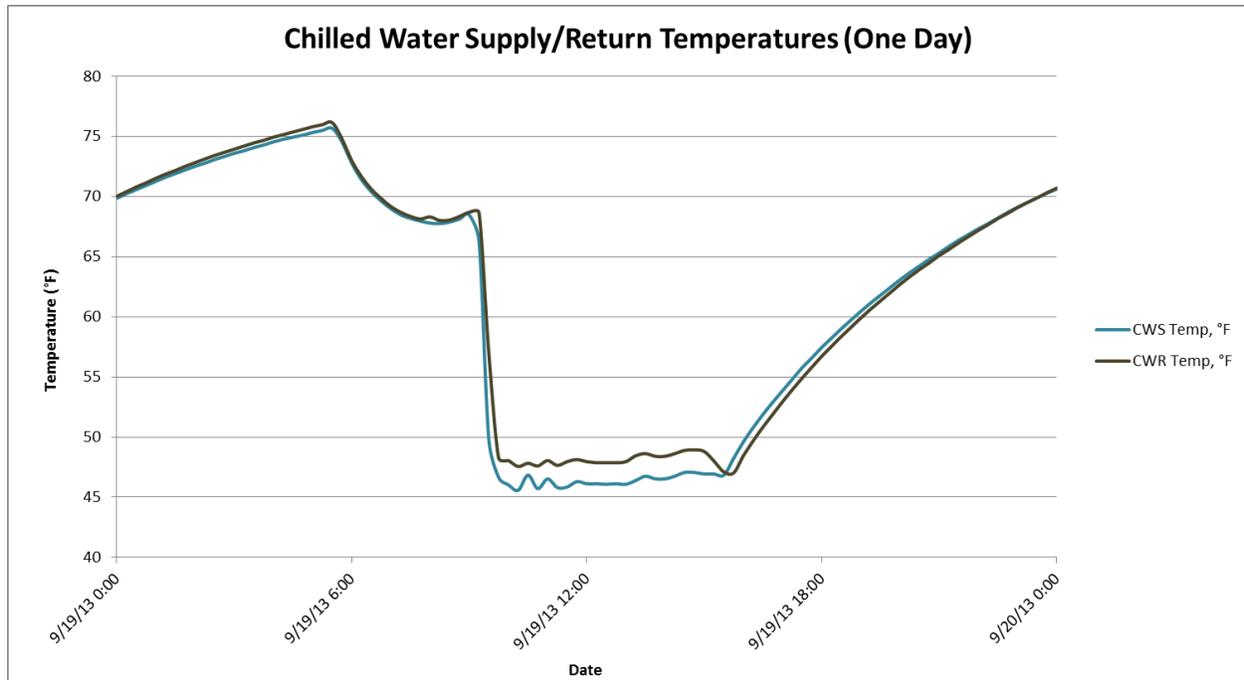
The above graph provides a summary of the chilled water supply & return temperature for a one day period. The chiller operated for only two days during the data logging time period. A 2°F temperature differential indicates only a small cooling load on the chiller.

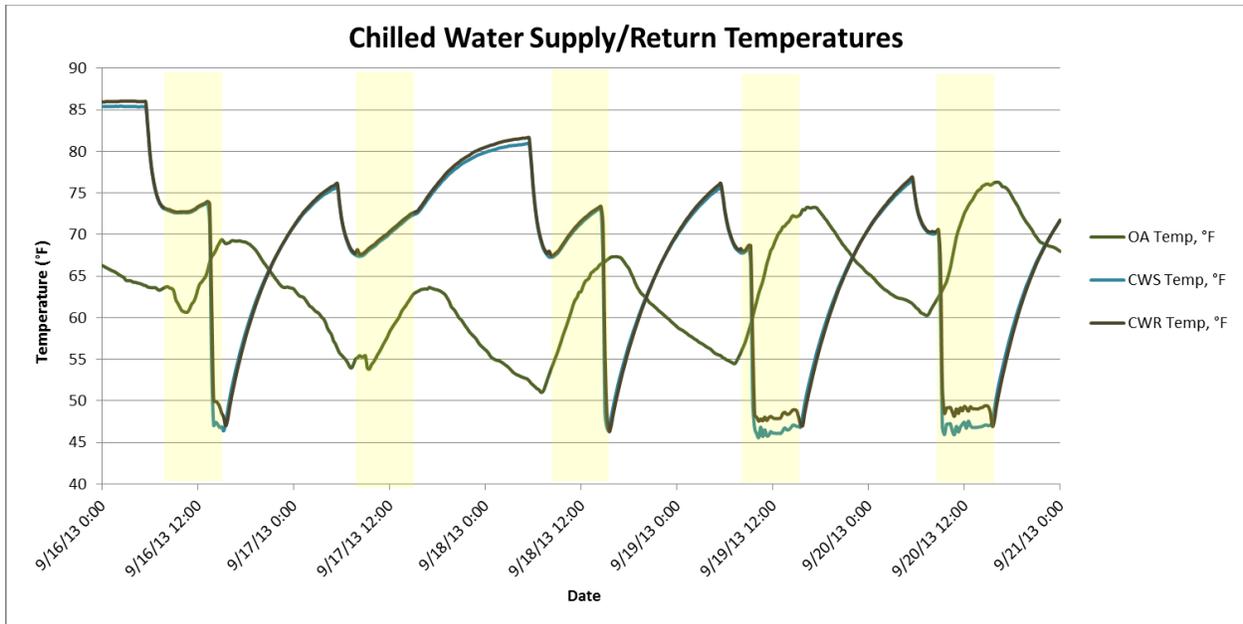
The graph above provides a summary of the chilled water supply and return temperature during the week. Based on the graph, the chiller was operated on Monday for a short time period and all occupied hours on Thursday and Friday. The chilled water supply temperature appears to be maintained at 46 to 47 deg F with little load on the chiller plant on Thursday and Friday.

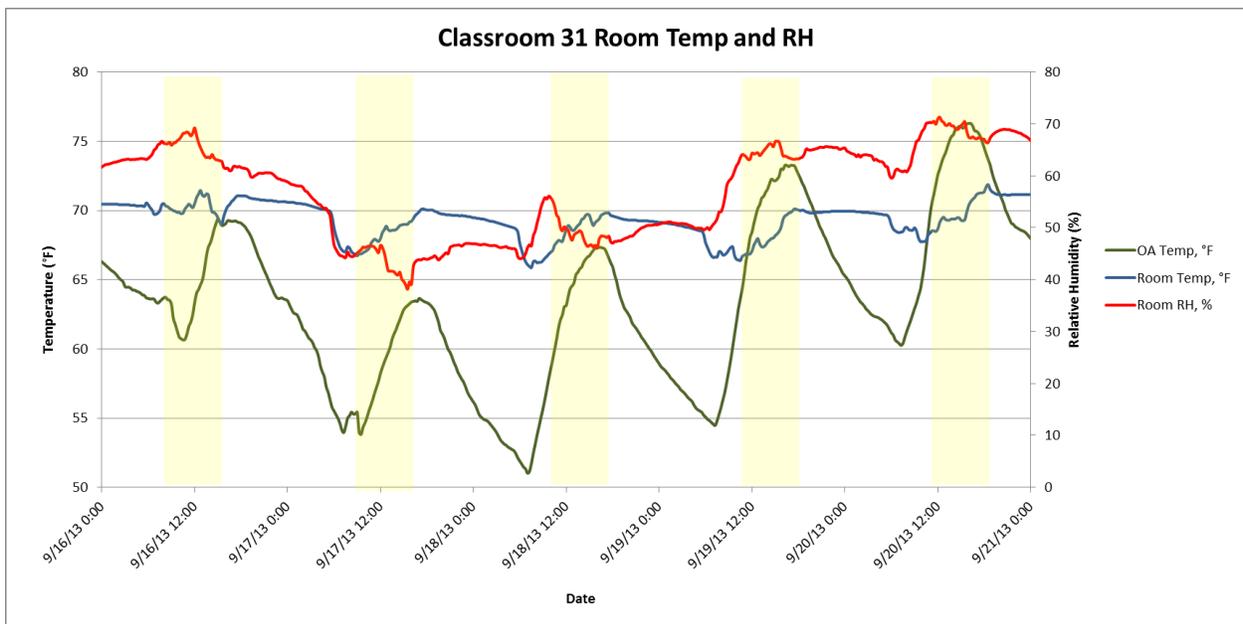
The above graph shows how the room temperature and humidity varies during the day and over the week. The yellow bars indicate the occupied time period for Monday through Friday. While the dry-bulb temperature remains fairly steady throughout the week, the room relative humidity percent increases along with the outside air temperature indicating high infiltration.

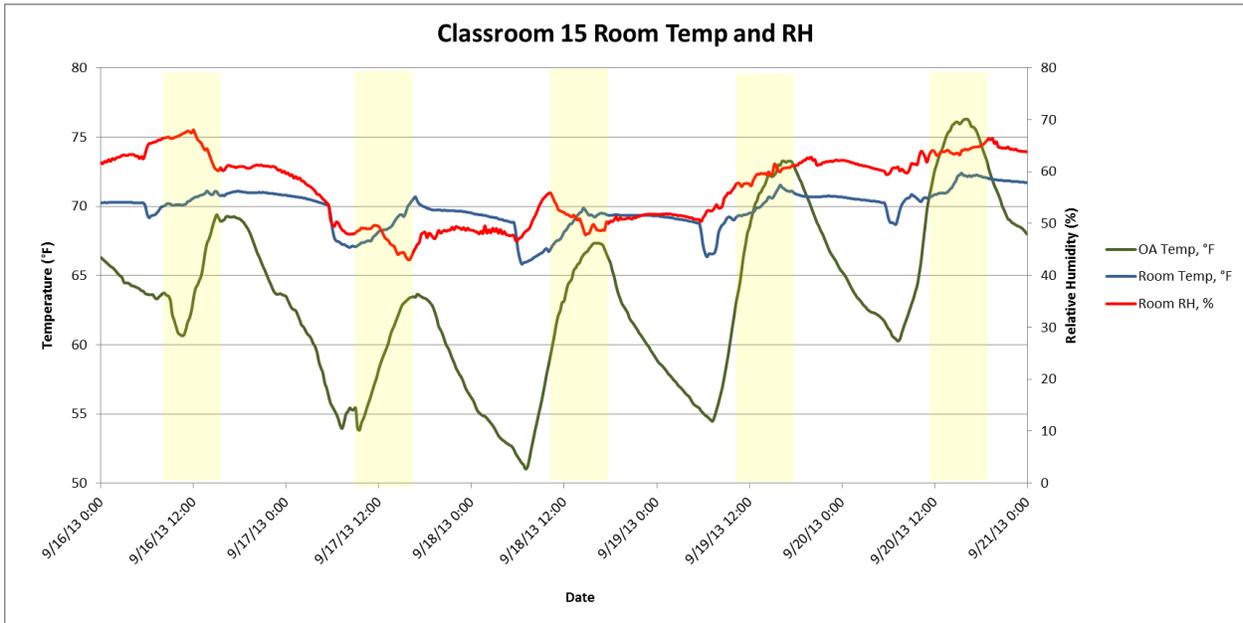
The above graph provides a view of the temperature and humidity within Classroom 15 during the week. Humidity levels were higher than expected on Monday and Thursday/Friday of the week. The dry-bulb temperature remained in the acceptable range throughout the week.

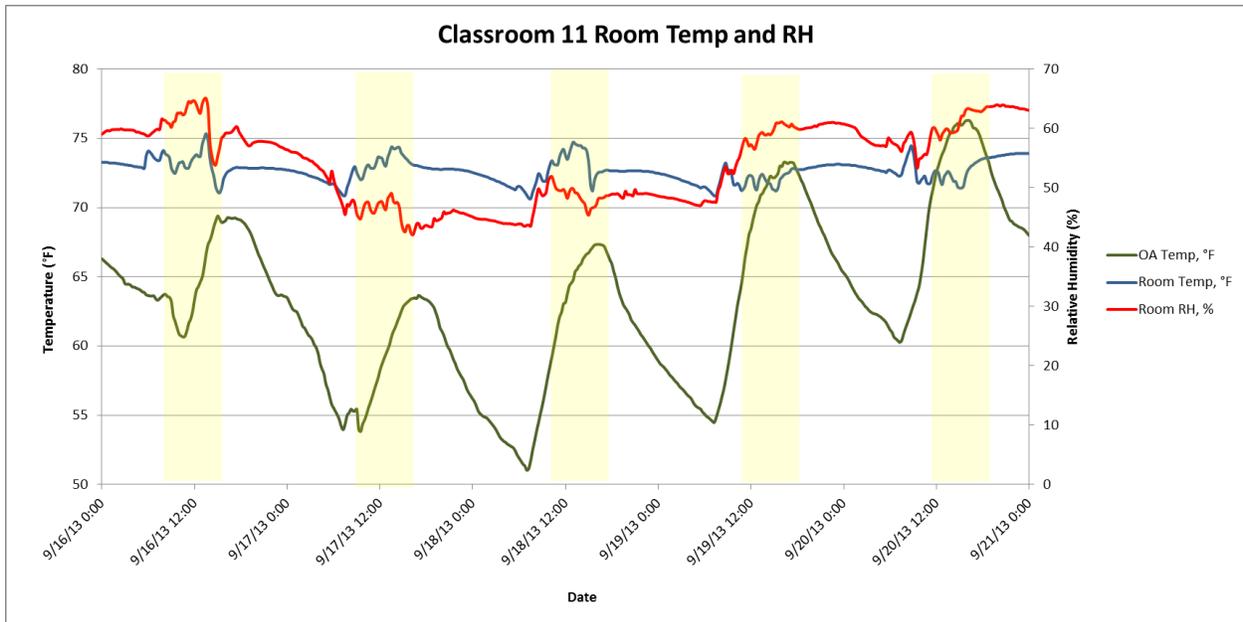
The above graph provides a summary of the temperature and humidity for Classroom 11. The temperature and humidity varies throughout the occupied time period and the dry-bulb temperature and humidity are outside of the normal range during the occupied time period. Peak conditions occurred on Thursday and Friday when the space temperature reached 73 to 75 degs F and the relative humidity peaked at 65%.

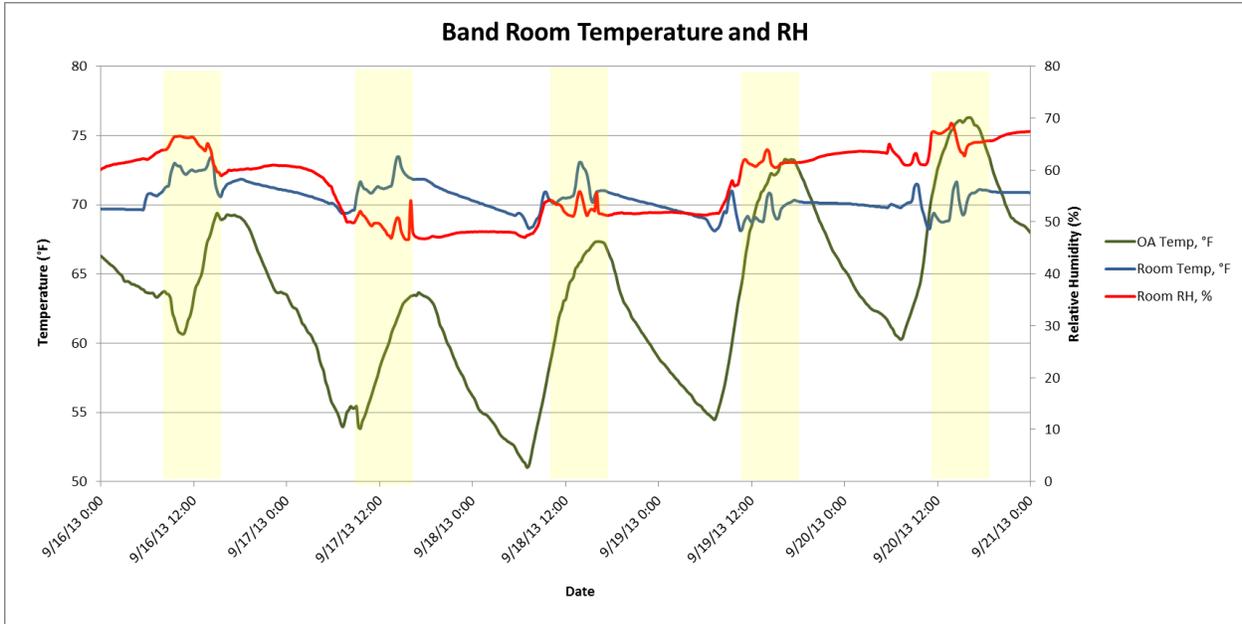
The Band Room contains a newer Trane unit ventilator. The graph above shows how the temperature and the humidity are maintained within acceptable ranges during the week.

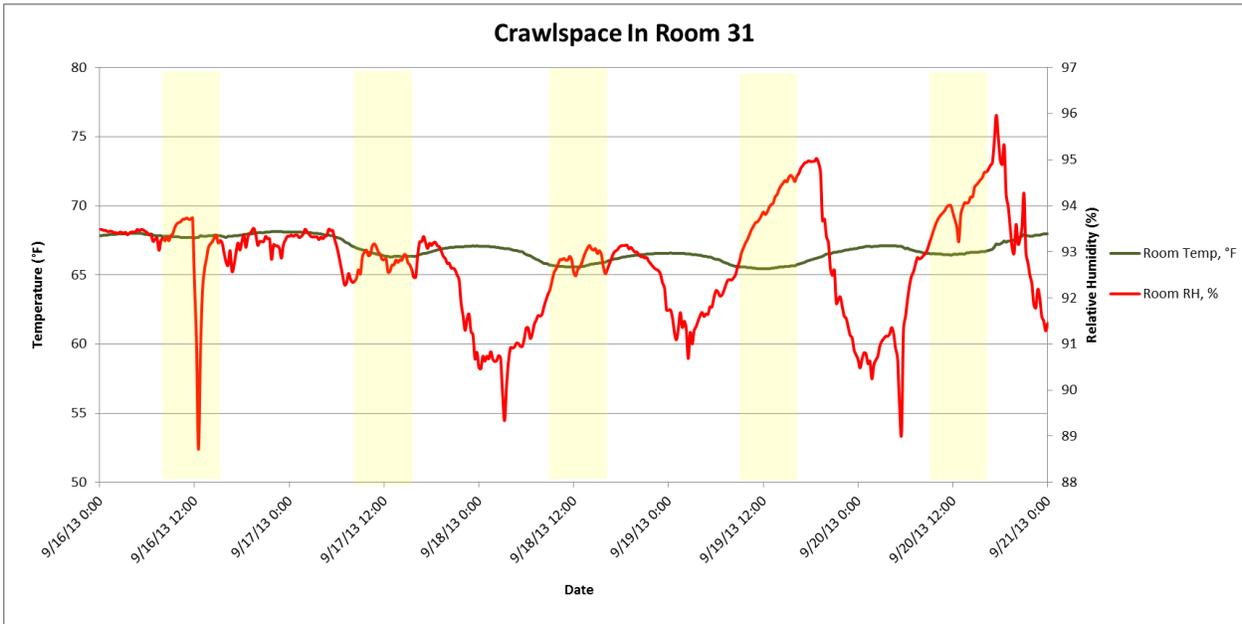
The abandoned steam tunnels are located under most classrooms in each of the classroom wings. The tunnels consist of block walls with dirt floors. One tunnel was checked during the site review and found to be very damp with a musty smell. The above graph provides a summary of the temperature and humidity in the tunnel crawlspace during the week. As can be seen in the graph, there were periods when the relative humidity reached 93 to 96% RH while the temperature maintained a consistent 68 deg F.

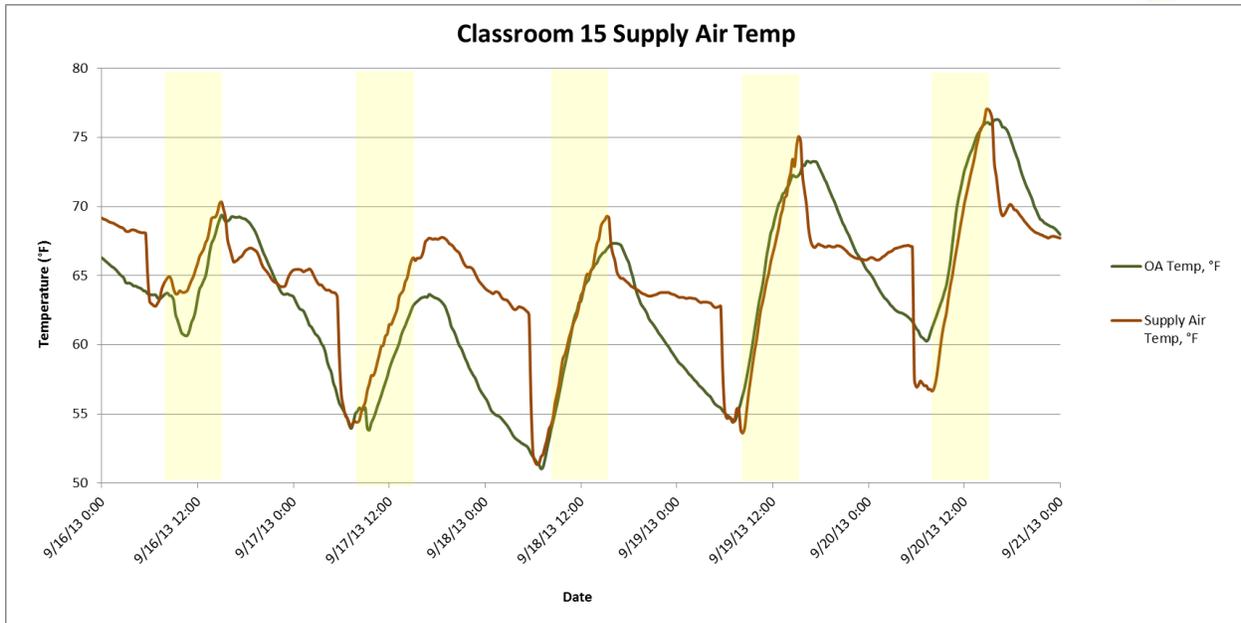
The above graph represents the supply air temperature (red line) discharging from the unit ventilator within Classroom 15. Supply air temperatures were high and out of the range needed to properly condition the space. However, the chiller was only operating on Thursday and Friday of the week. It appears that the chiller operation does not have an impact on the supply air temperature within the room indicating problems with the controls.

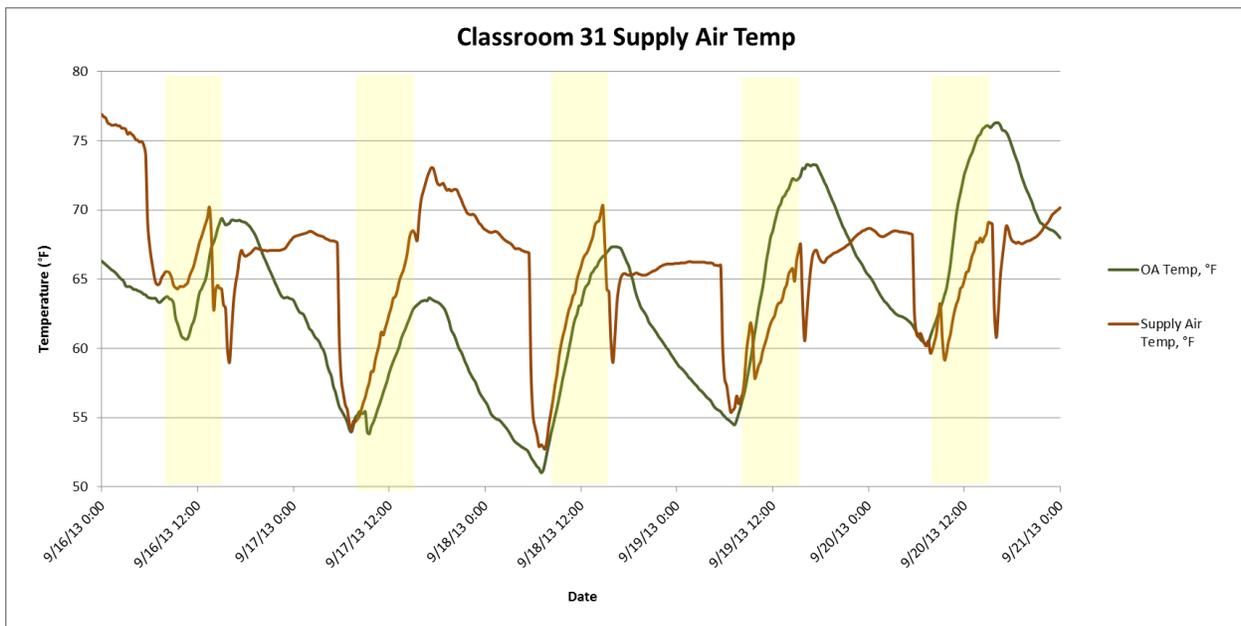
The above graph represents the supply air temperature (red line) discharging from the unit ventilator within Classroom 31. Supply air temperatures were within range during portions of the week, but were high on Thursday and Friday.

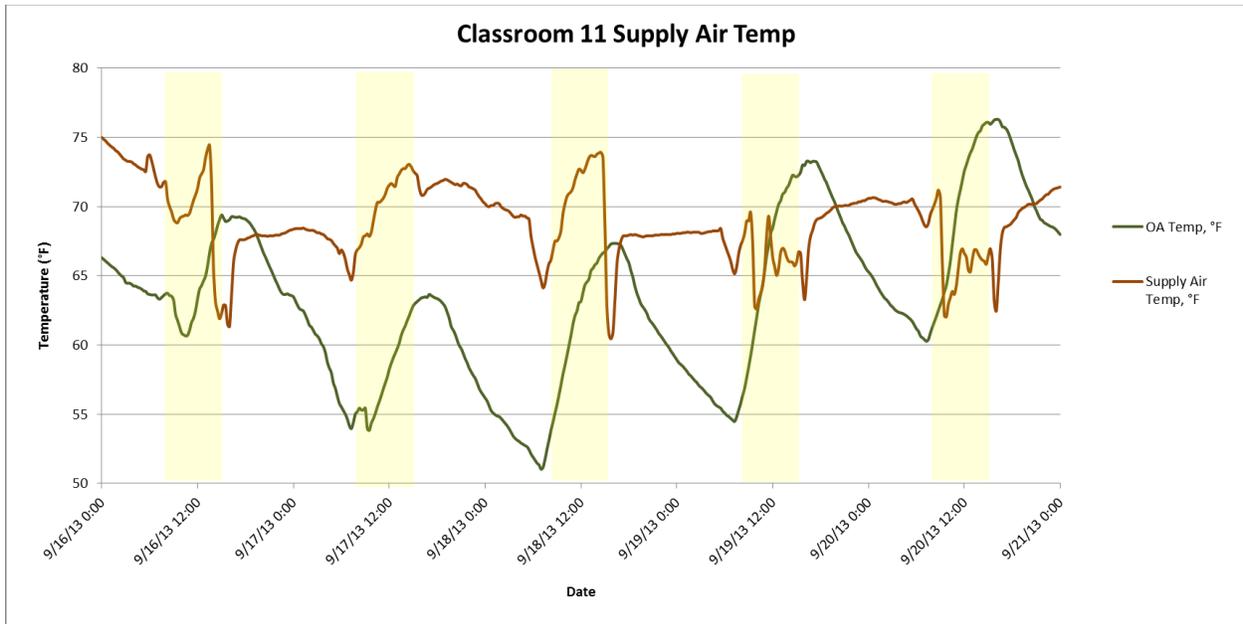
The above graph represents the supply air temperature (red line) discharging from the unit ventilator within Classroom 11. Supply air temperatures were high during the entire week and remained high even when the chiller plant was operational on Thursday and Friday.

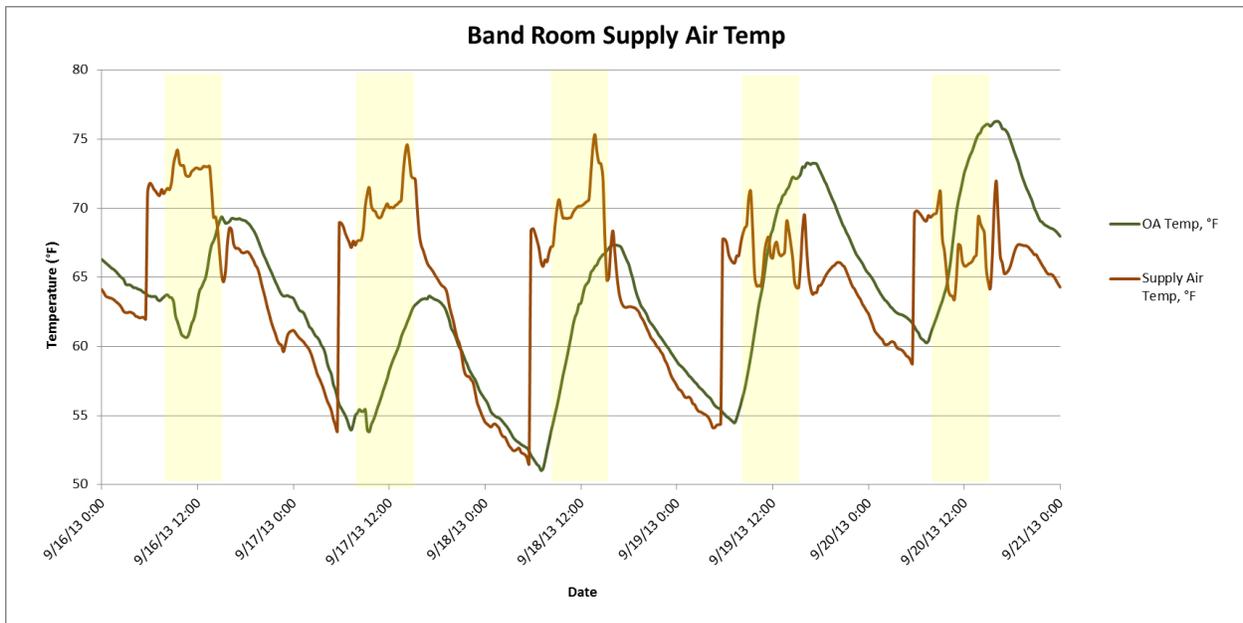
The above graph represents the supply air temperature (red line) discharging from the unit ventilator within the Band Room. The supply air temperature dropped during the night time hours indicating that the Trane unit remained operational throughout the unoccupied time periods or there was a large amount of air leakage through the Trane unit ventilator permitting outside air to cross over the data logger while the unit was off.
